SITE : PLAN - PHASE 1 | FIESTA GARDENS

2101 JESSE E. SEGOVIA ST. AUSTIN, TEXAS 78702

HISTORIC LANDMARK COMMISSION | PRELIMINARY - NOT FOR CONSTRUCTION | MARCH 22 2021 | 6 OF 65

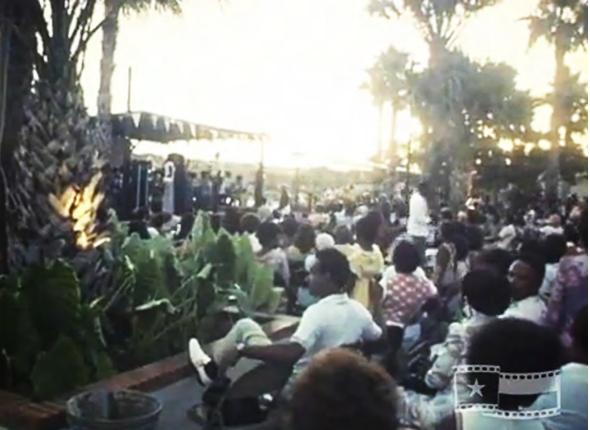
## **BANDSTAND - HISTORY**

- Original steel roof structure removed between 1973-1980; current structure is wood trellis that evokes the site's typical wood details but are in need of replacement
- Elevated concrete stage with non-compliant stair and non-original ramp that projects into plaza
- Performers face Dining Hall off center from Dining Hall entry and historic planting beds

- Rebuild wood structure per improved 1980s details
- · Improve lighting and power
- Expand structure to better address plaza, improve code compliance, and move compliant vertical circulation to rear
